EXHIBIT L

Brine Pit Piping Maintenance Project

Completed in October 1995; Coated with a standard epoxy coating; Photos taken 10+ years later

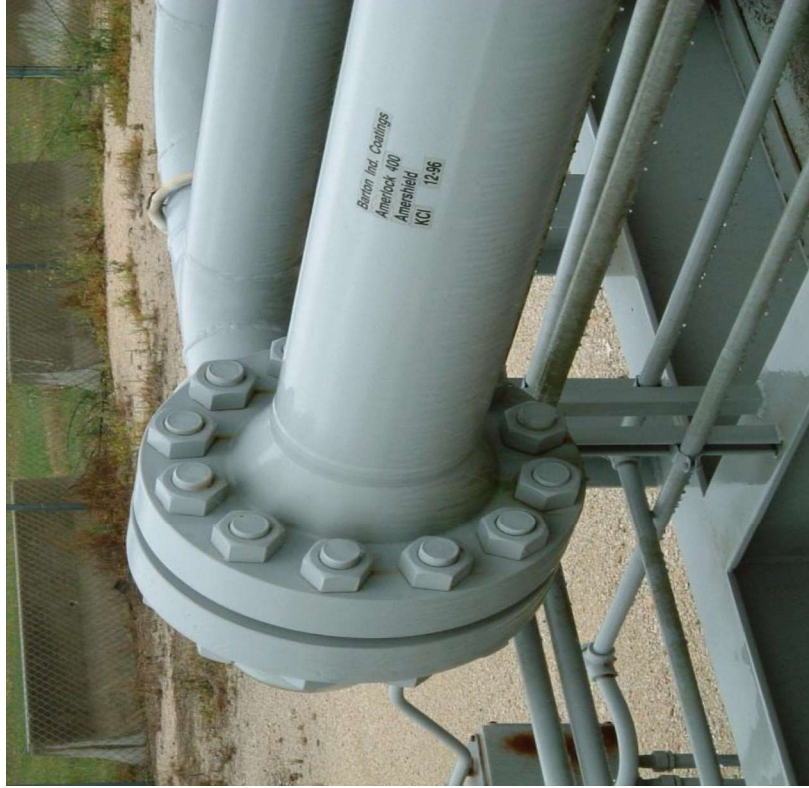
- **No additional coating or maintenance**
- **No corrosion even on the bolt threads**
- **Two similar sites, completed at the same time using traditional surface preparation methods, were re-treated 4 times in 11 years**
